# LAKE LACKAWANNA

### NJ 00817

## PHASE 1 INSPECTION REPORT NATIONAL DAM SAFETY PROGRAM

Lake Lackawanna Dam (NJ-00817).  
Delaware River Basin, Lubbers  
Run, Sussex County, New Jersey.  
Phase 1 Inspection Report.

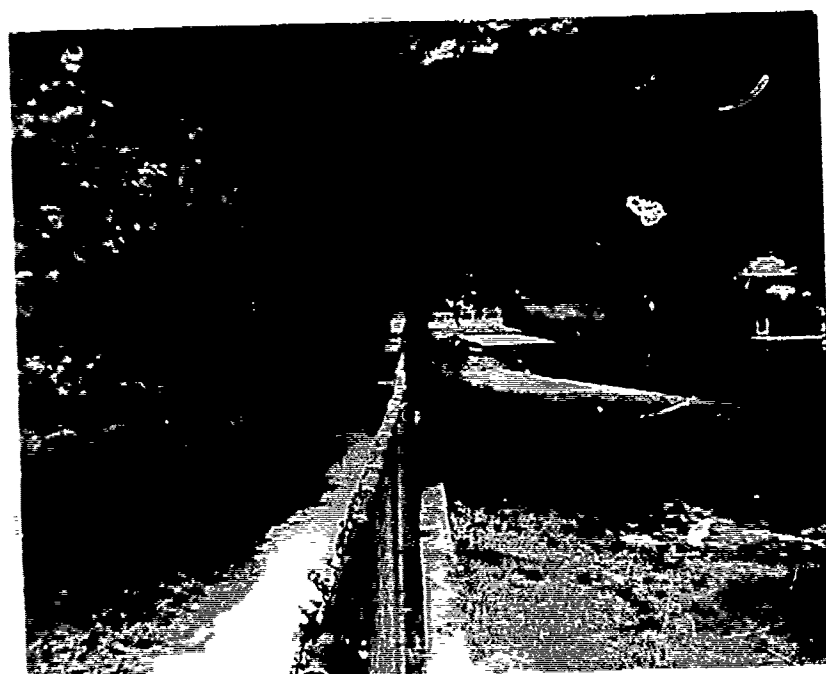
No deficiencies of a structural nature were noted during the inspection of this dam. The crest is uniform in a horizontal plane and the height-to-width ratio is conservatively modest (1.4:1). No indications of mass movement of material, such as settlement, sloughing, or cracking, were noted.

View of Dam Crest

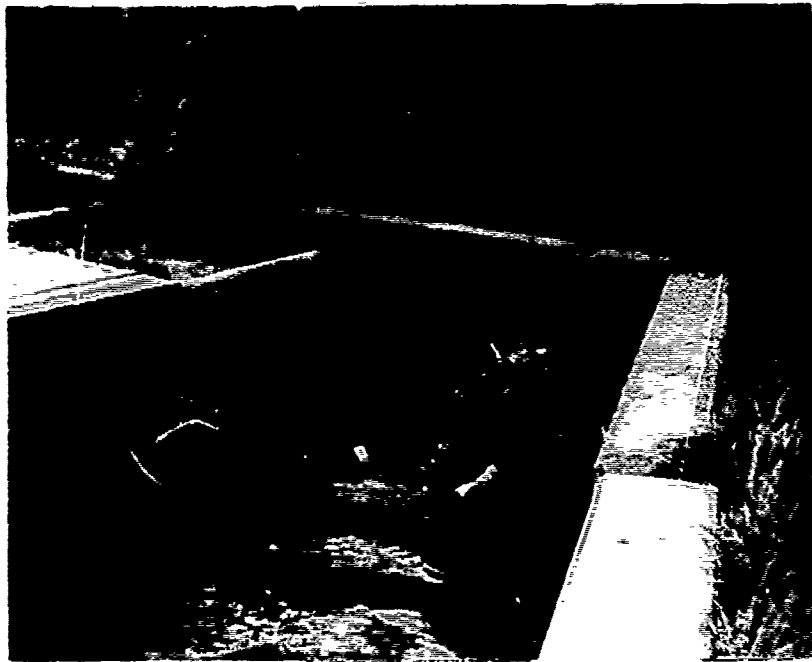
VISUAL EXAMINATION OF	OBSERVATIONS	REMARKS OR RECOMMENDATIONS
SURFACE CRACKS	None observed	
UNUSUAL MOVEMENT OR CRACKING AT OR BEYOND THE TOE	None observed	
SLOUGHING OR EROSION OF EMBANKMENT AND ABUTMENT SLOPES	Light erosion on center of downstream slope and at junction of embankment at left wingwall of spillway.	May be due to foot traffic. Should be filled, graded, and sodded.
VERTICAL AND HORIZONTAL ALIGNMENT OF THE CREST	Crest alignment is generally good. However, upstream face of embankment somewhat irregular due to establishment of a bathing beach at one end and construction of a deck near the spillway.	Wave action is funnelled between deck and concrete walls adjoining spillway, increasing erosion at this point. Eroded area should be filled and wave protection provided.
RIPRAP FAILURES	None observed

Erosion At Upstream Embankment

(2) Provide protection against wave erosion on the upstream face of the dam.
